Manhole Inspection Summary

Manhole # S21A__032MH

Insp Date: **9/14/07 7:33 AM**

Location Address: **722 ALL-FULTON-MOUNT**

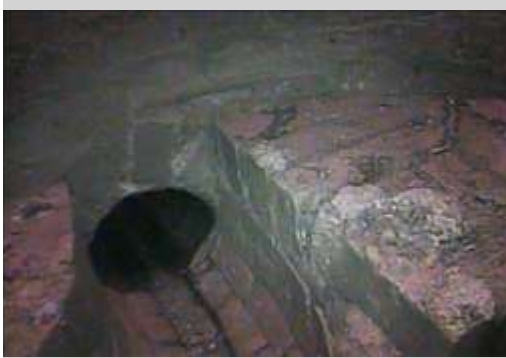
Defect 6

Condition: ☐ Sound ☐ Cracked ☐ Root Intrusion ☒ **Deteriorated** ☐ Leaks ☐ Debris

SLIGHTLY DETERIORATED BENCH

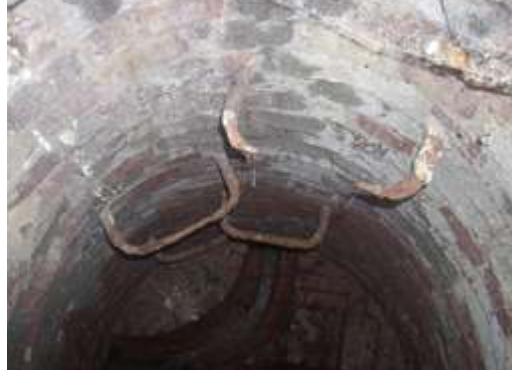
Defect 5

Count: **3** Missing: **1** ☒ **Corroded**

CORRODED AND MISSING STEP

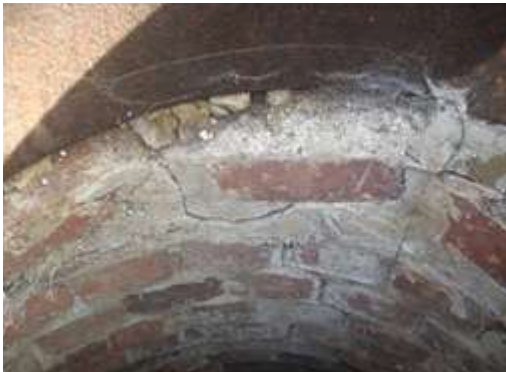
Defect 4

Condition: ☐ Sound ☒ **Cracked** ☐ Root Intrusion ☐ Loose Brick ☒ **Deteriorated**

CRACKED AND DETERIORATED
CHIMNEY

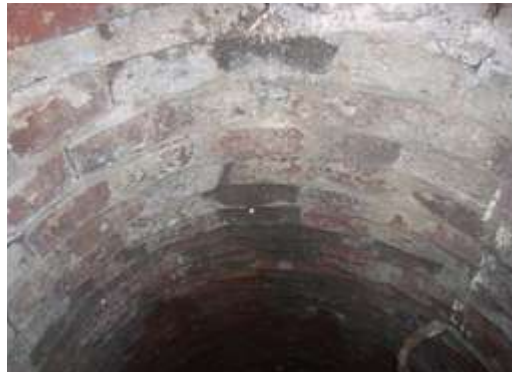
Defect 3

Infiltration: ☐ None ☐ Joint ☐ Cracks ☐ Mortar ☐ Roots ☒ **Wall**

INFILTRATION OF THE CORBEL WALL

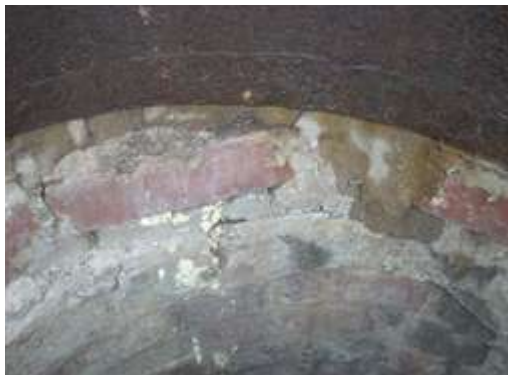
Defect 2

Infiltration: ☐ None ☐ Joint ☐ Cracks ☐ Mortar ☐ Roots ☒ **Wall**

INFILTRATION OF THE CHIMNEY WALL

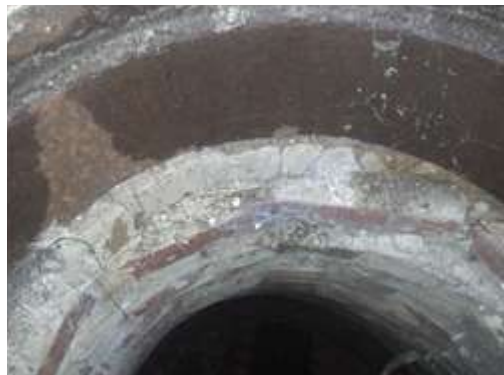
Defect 1

Offset: **3** (in.)

FRAME OFFSET

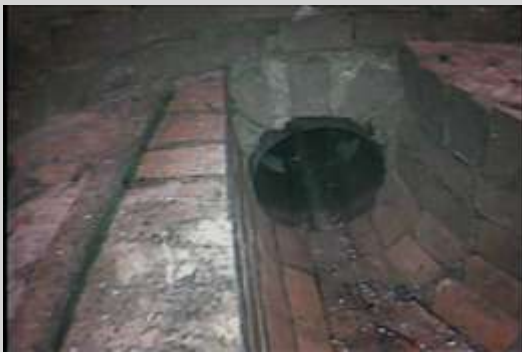
12 O'Clock Outflow

8 in. Circular Gravity Sewer
Pipe Out @ 12 O'Clock

Pipe Height: **8.4** (in.) Rod and Bar (Angled)
Pipe Material: **Clay** ☐ Pipe Lined
Invert Depth: **8.49** (ft.) Flow Characteristics: **None**
Deposits: ☒ None ☐ Mud ☐ Sludge ☐ Debris ☐ Grease
Silt Depth: (in.) Deposits Extent:
Infiltration: **None** Pipe Seal Cond: **Sound**

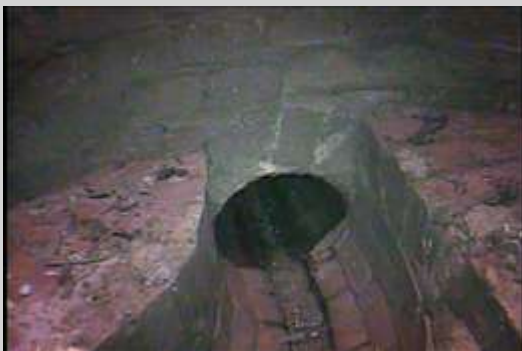
3 O'Clock Inflow

8 in. Circular Gravity Sewer
Pipe In @ 3 O'Clock

Pipe Height: **8.4** (in.) Rod and Bar (Angled)
Pipe Material: **Clay** ☐ Pipe Lined
Invert Depth: **8.19** (ft.) Flow Characteristics: **None**
Deposits: ☒ None ☐ Mud ☐ Sludge ☐ Debris ☐ Grease
Silt Depth: (in.) Deposits Extent:
Infiltration: **None** Pipe Seal Cond: **Sound**

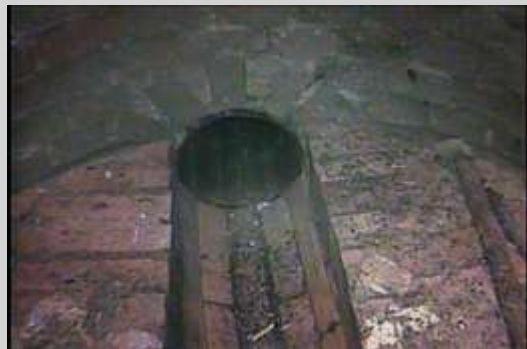
6 O'Clock Inflow

8 in. Circular Gravity Sewer

Pipe In @ 6 O'Clock

Infiltration: **None** Pipe Seal Cond: **Sound**
